Environmental Baseline Survey Enhanced Use Lease - 2010 U.S. Army Installation Management Command and Fort Leonard Wood

Environmental Baseline Survey

Enhanced Use Lease - 2010

Fort Leonard Wood

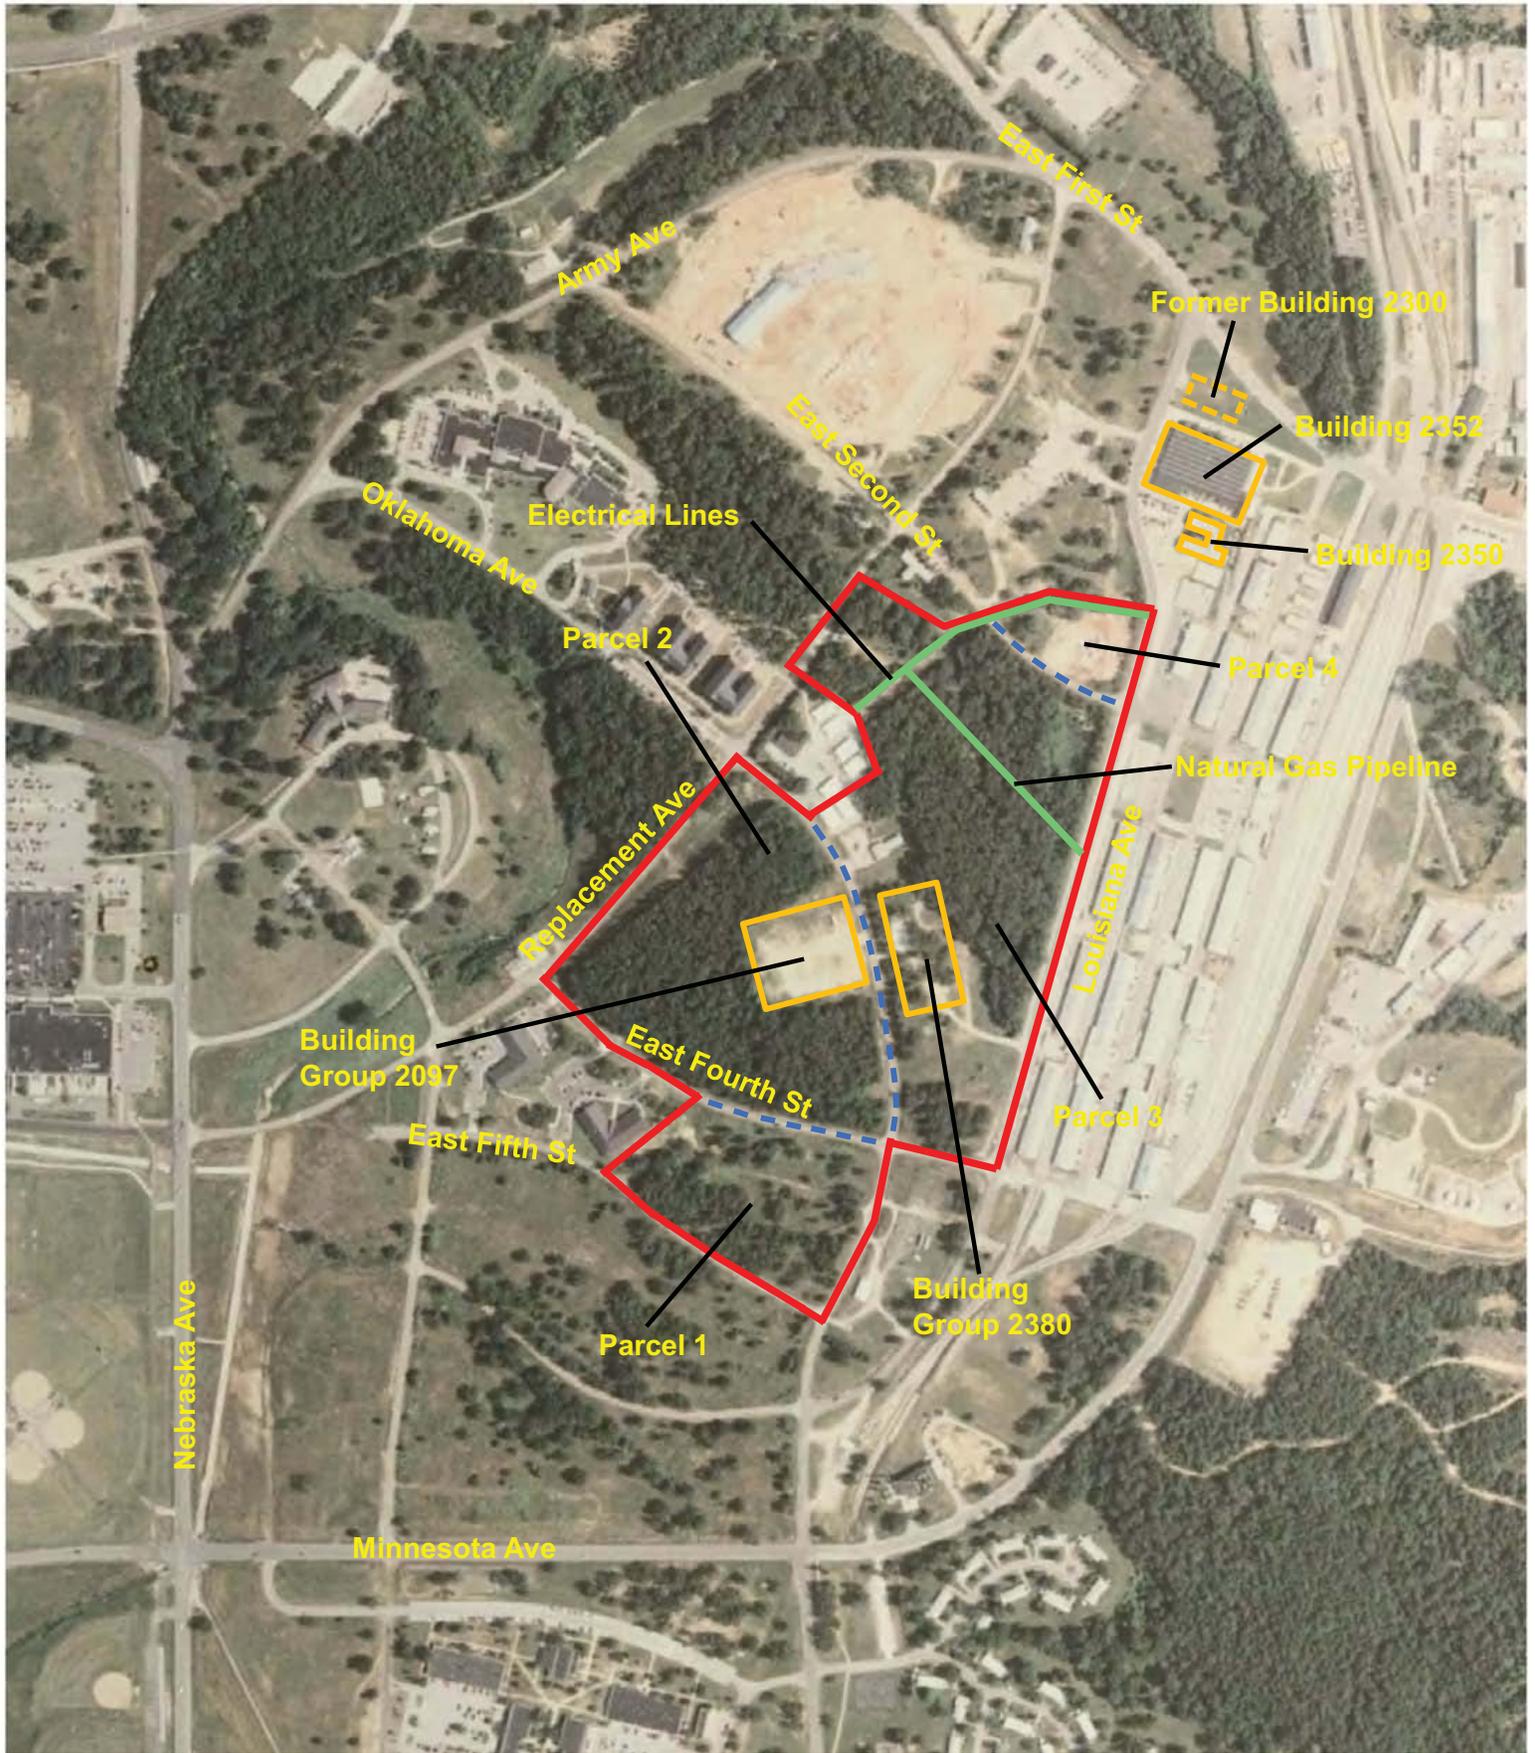
Figure 2
Environmental Baseline Survey – Enhanced Use Lease – 2010
Fort Leonard Wood, Missouri

This Environmental Baseline Survey (EBS) was performed to determine the environmental condition and to facilitate the proposed lease of real property and proposed development of the Fort Leonard Wood Enhanced Use Lease. The subject property consists of approximately 60 acres of real property at the U.S. Army Installation Management Command and Fort Leonard Wood, Missouri. Fort Leonard Wood is located approximately 120 miles southwest of St. Louis, Missouri. The real property is bounded by East Fifth Street on the south and an area north of East Second Street on the north, by Replacement Avenue on the west, and Louisiana Avenue on the east (**Figure 2**).

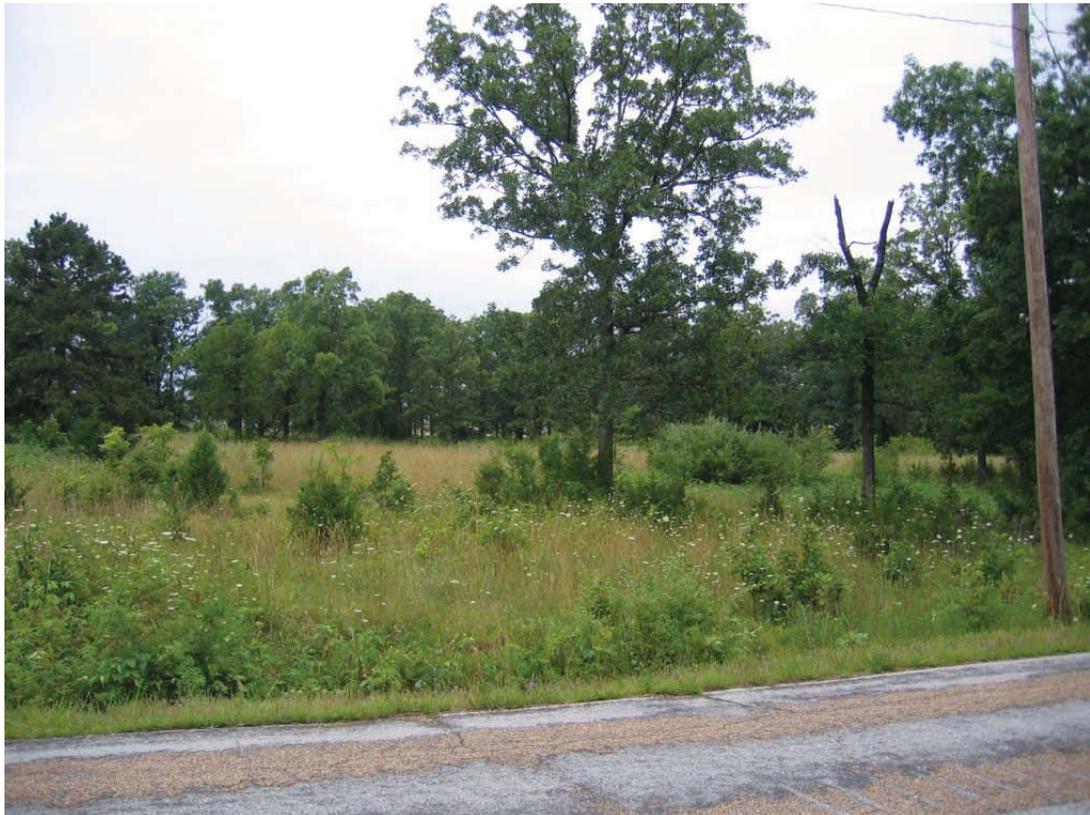
Photo 1

Description: Unoccupied parcel with a vegetative cover of native grasses, wildflowers, poison ivy, and cedar, pine, hickory, and oak trees.

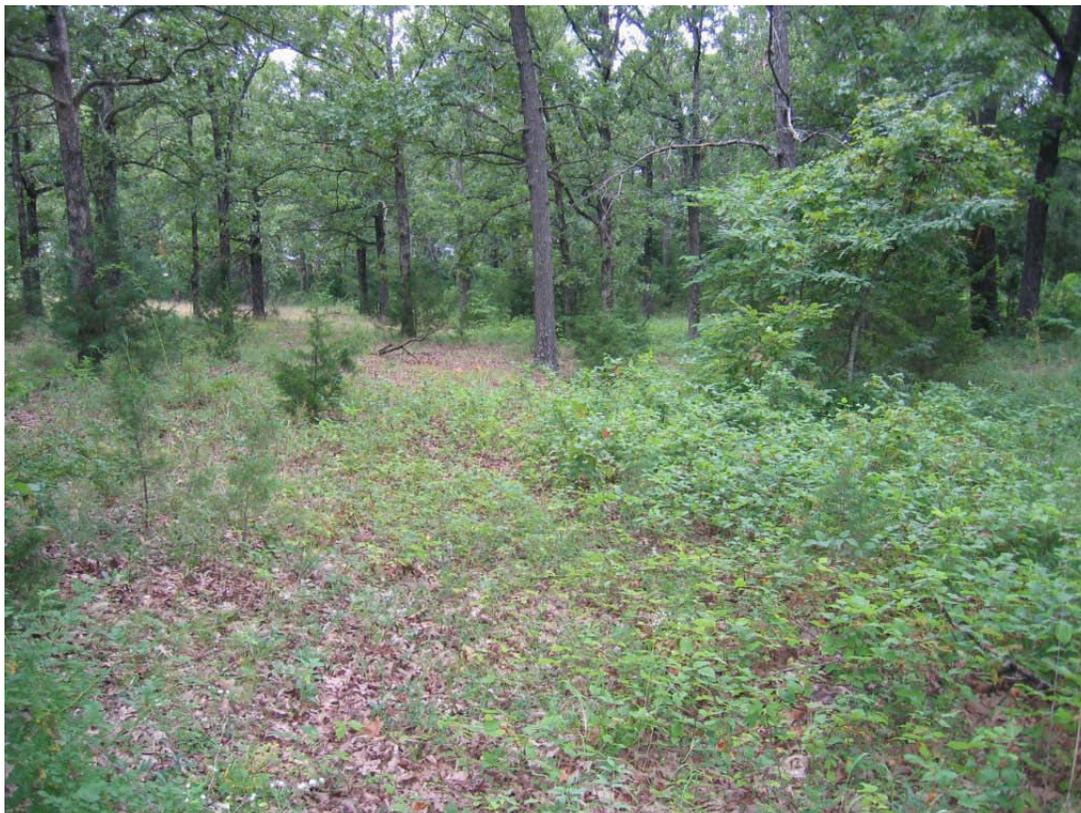
Photo 2

Parcel 2 – this property is heavily wooded, consisting of a mix of poison ivy and cedar, red bud, hickory, and oak trees (**Photo 2**). An intermittent, unnamed drainage was present in the center of the property and the general slope of the parcel is from east to west. Two areas, however, are cleared of vegetation. The first is a grassy area cleared for power lines and running parallel to Replacement Avenue along the northwest edge of the parcel. The second is an area of approximately four acres on the east central portion of the parcel abutting Oklahoma Avenue (**Figure 3**). This area is occupied by Building Group 2097 and is covered by a thick layer of three-inch limestone gravel. In addition to the structures, this

Description: Typical vegetative cover in Parcel 2 consisting of poison ivy and cedar, red bud, hickory, and oak trees.

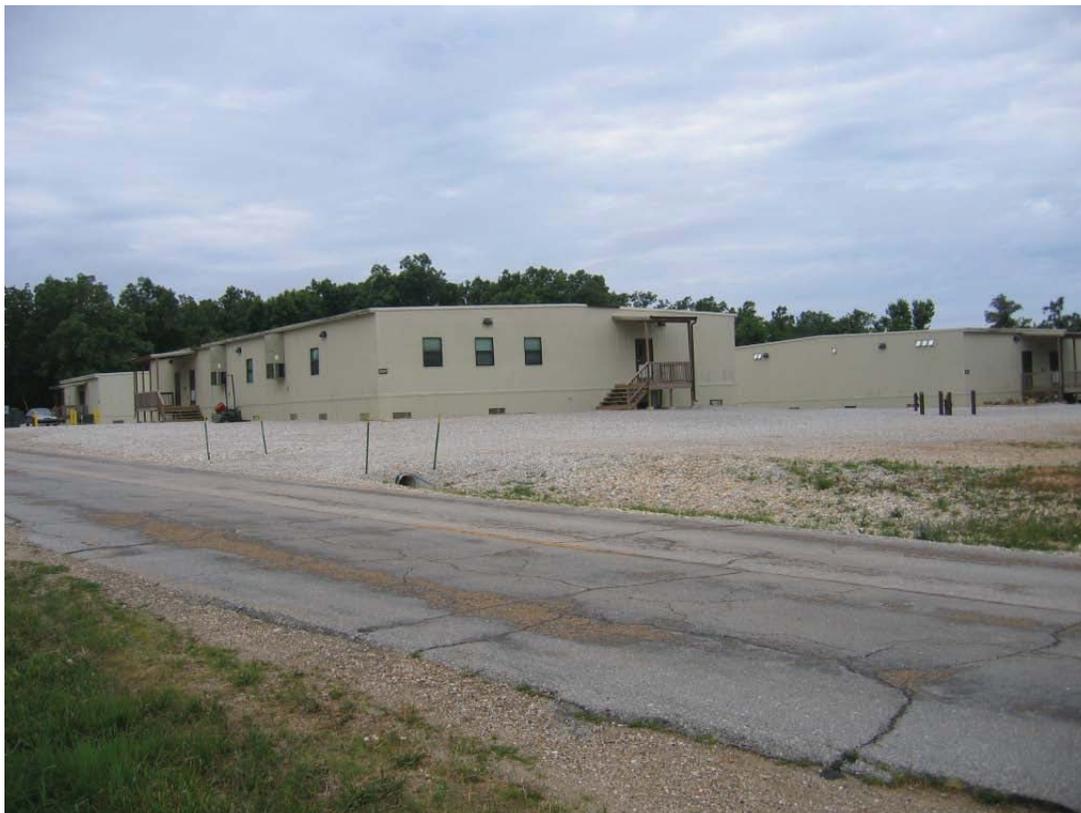
Photo 3

The subject property was visually and physically inspected and photographed. VSIs were conducted on July 7, 2010, and August 6, 2010, to document current site conditions and hazardous substance use and storage. The July 7, 2010, VSI focused on two parcels (Parcel 1 and Parcel 2) that constitute the southern portion of the subject property. *Parcel 1* is bounded by East Fifth Street on the south, East Fourth Street on the north, Oklahoma Avenue on the east, and the University of Missouri Business and Technology Park complex to the west. This parcel is unoccupied, sparsely to moderately vegetated land, consisting of native grasses, cedar, hickory, pine, and oak trees. *Parcel 2* is bounded by Oklahoma Avenue on the north and east, East Fourth Street on the south, and Replacement Avenue on the west. This parcel is primarily unoccupied, heavily vegetated land, consisting of cedar, hickory, and oak trees. A cleared area of approximately four acres in the east central portion of Parcel 2, along Oklahoma Avenue is occupied by relocatable buildings (Building Group 2097) (**Photo 3**).

Description: Relocatable barracks along Oklahoma Avenue in the east-central portion of Parcel 2.

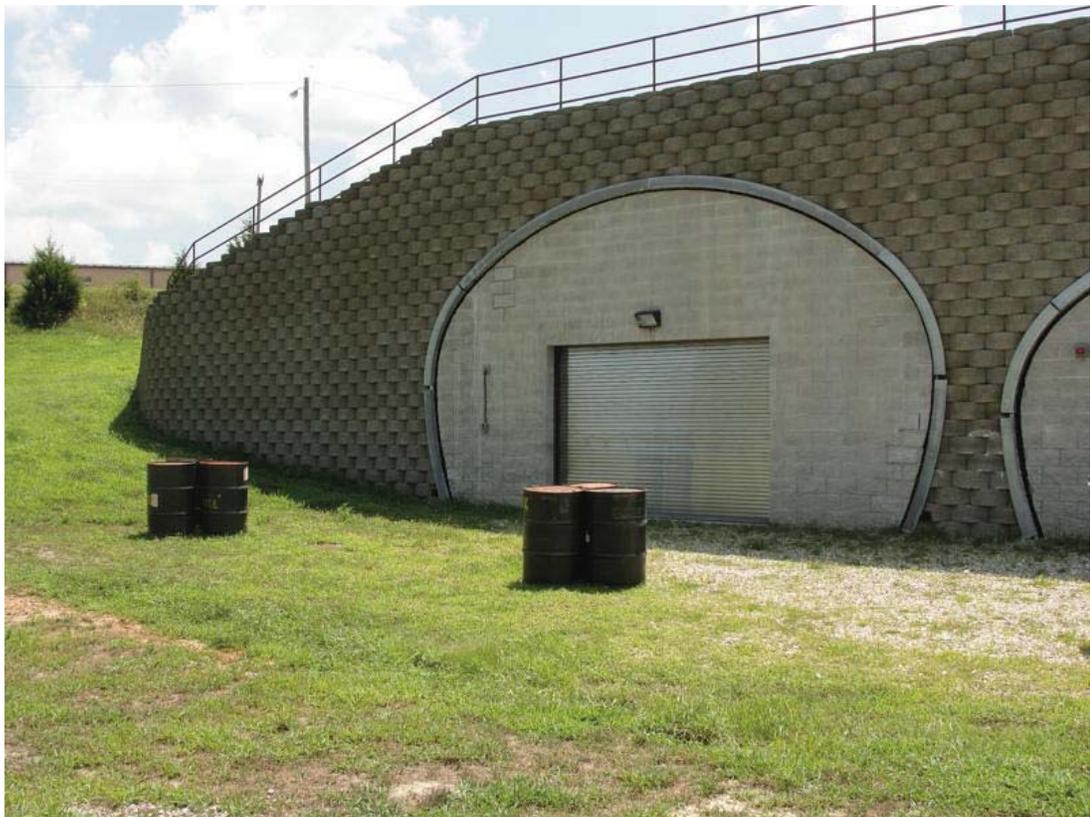
Photo 4

Parcel 4 – this property is primarily an open area with some trees but contains an underground cave for training troops (**Photo 4**). Two entrances to the cave are covered by metal garage doors. The doors were locked and appear to be electronically controlled. Outside the cave entrance was six empty, rusted, 55-gallon metal drums apparently used in training exercises from the markings “TRNG USE” posted on the sides. A small, intermittent drainage bisects the parcel in a northeast to southwest orientation. Power lines form the boundary with the Chemical, Biological, Radiological, and Nuclear Responders Training Facility to the north and northwest. A power control box, a 25-KVA transformer, a water hydrant and drinking fountain (not working), a portable toilet, and a sanitary sewer manhole were observed in this parcel. Additional sanitary sewer manholes were also observed on the adjacent property between Building 2136 to the north and the Chemical, Biological, Radiological, and Nuclear Responders Training Facility to the northwest.

Based on the records search and interviews, there is no evidence of drums containing hazardous substances or petroleum products being stored at the subject property. Six empty, rusted 55-gallon metal drums were observed in Parcel 4 during the August 6, 2010, VSI, outside the entrance to the training caves. The drums were neatly arranged and had markings (TRNG USE) indicating they were still used for training exercises.

Description: Entrance to underground cave used for training troops. A second entrance is just to the right in this photograph. The six, 55-gallon metal drums were empty and designated "TRNG USE."

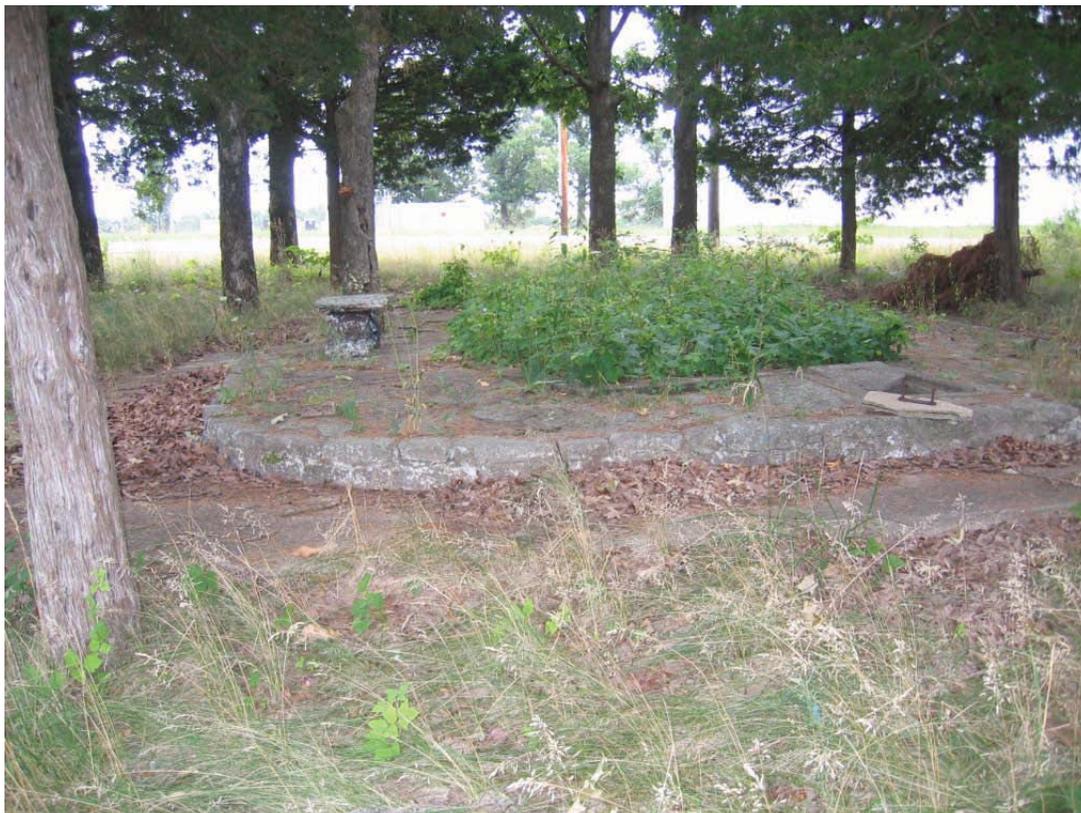
Photo 5

Two stonework structures were observed in the southeastern portion of Parcel 1. The first was a two-tiered, semi-circular structure approximately 22 feet (ft) wide by 33 ft long constructed of native stone and concrete surrounding a depressed area filled with random, volunteer plants and grasses (**Photo 5**). A fire pit, a stone bench and the base for a second bench were situated around the depressed area (**Photos 6 and 7**). An opening in the concrete on the west end of the depressed area contained a small-diameter galvanized steel pipe leading underground and away from the structure. The pipe was likely a drain pipe for what appeared to be a reflecting pond or patio and garden [as described in the *Finding of Suitability to Lease, Phase I of the Proposed Technology Park* (Tech Park FOSL) (BHE, 2000)]. The concrete opening is visible on the right side of **Photo 5** behind the stone cover with the handle.

Description: Stonework structure in the southeast portion of Parcel 1 constructed by World War II prisoners of war.

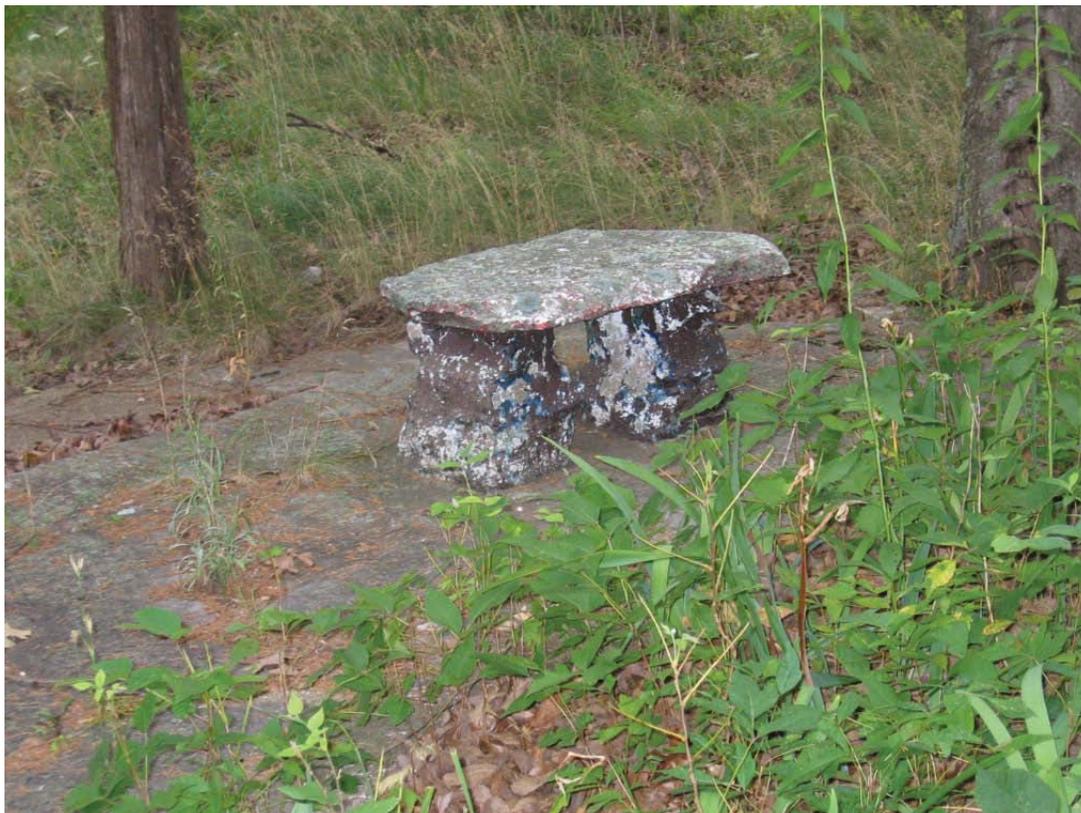
Photo 6

Description: Stone bench in the southeast portion of Parcel 1 constructed by World War II prisoners of war.

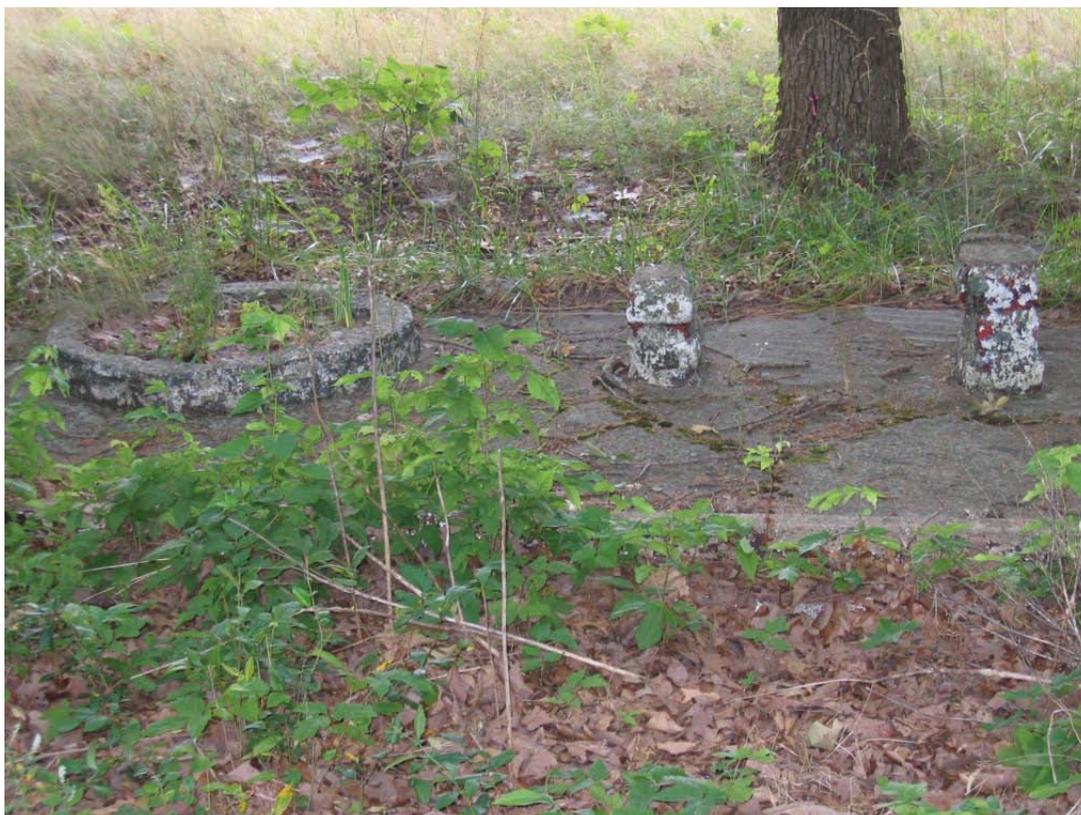
Photo 7

Description: Fire pit and based of stone bench in the southeast portion of Parcel 1 constructed by World War II prisoners of war.

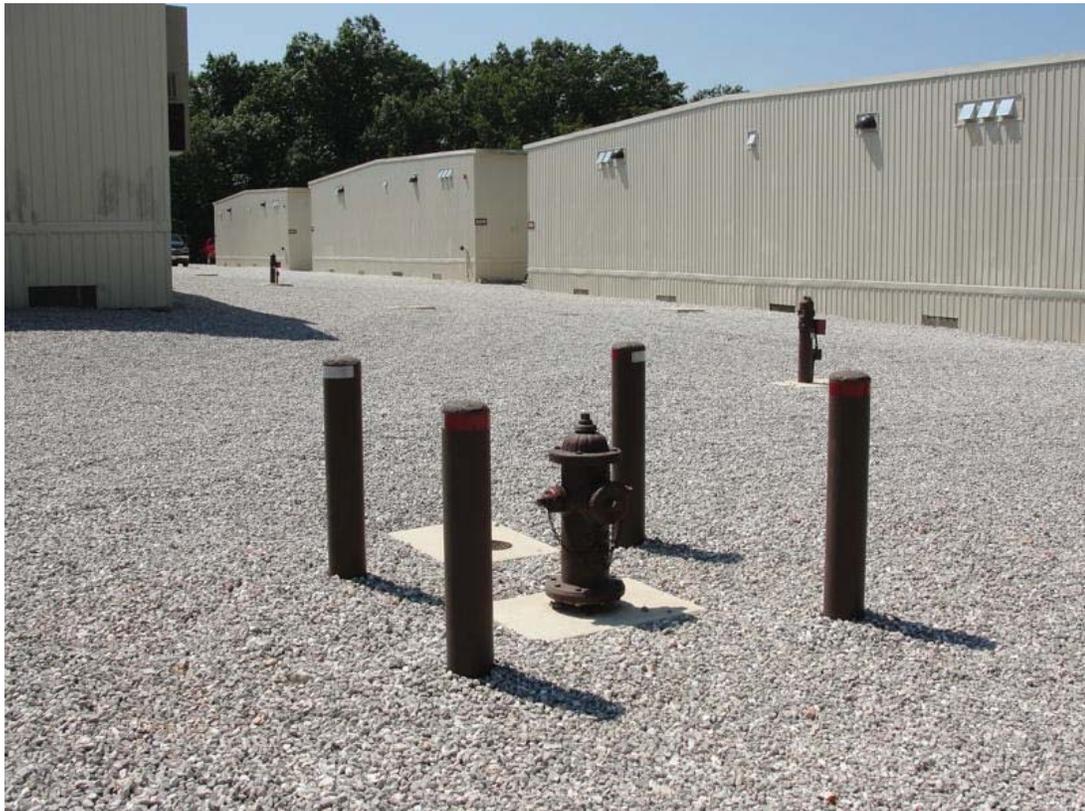
Photo 8

Description: Fire hydrant surrounded by protective bollards at Building Group 2097. Two of four fire mains are shown in the background.

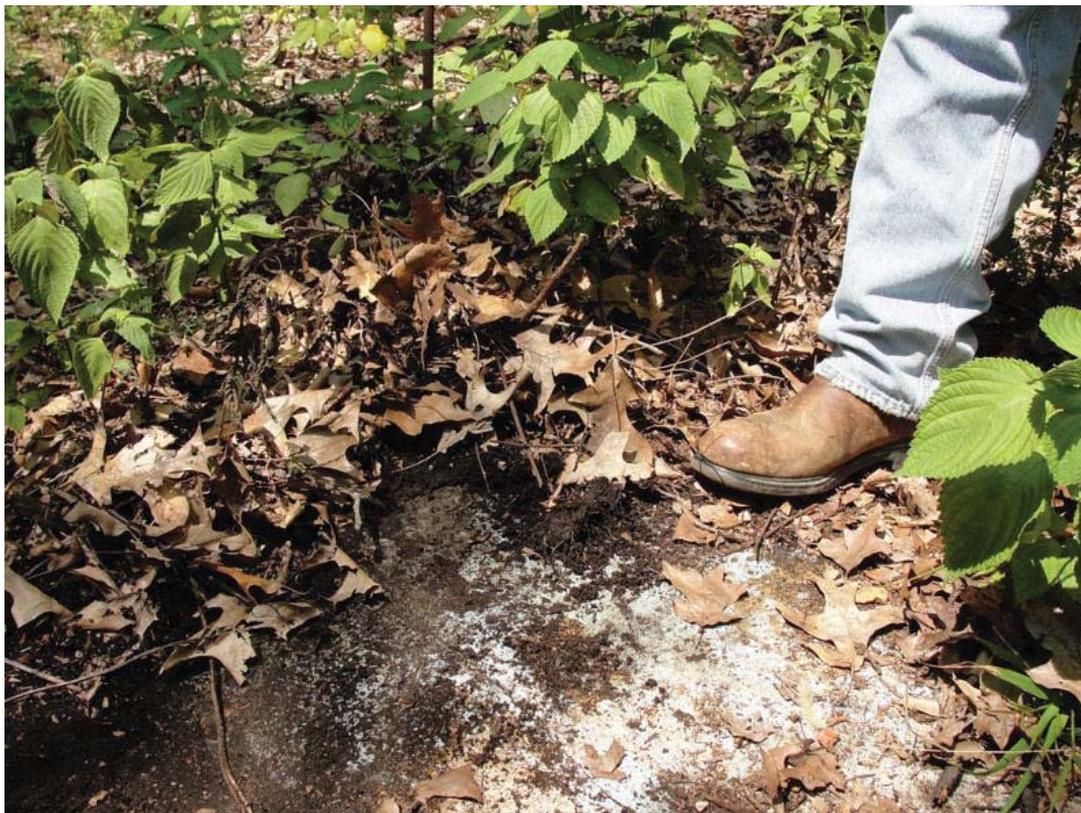
Photo 9

A brick electrical substation and two, 1,000-gallon above-ground storage tanks (ASTs) were observed in the westernmost portion of the parcel off of Replacement Avenue. The ASTs appeared to be new and were situated on the south side of the electrical substation. The area is crossed by a natural gas pipeline with a northwest to southeast orientation and electrical lines with a southwest to northeast orientation. The power lines form the northern boundary of Parcel 4. Also in this area were the remnants of a swimming pool. Portions of the concrete floor (**Photo 9**) were observed during the VSI. The Tech Park EBS identified small-diameter steel pipes, similar to UST fill pipes or vent pipes, extending out of the ground in the area of the former swimming pool. No evidence of fill or vent pipes was observed during the VSI, however, small-diameter steel rebar (**Photo 10**) was observed and appeared to form the border of the former swimming pool. The shallow and deep ends of the swimming pool were still discernable.

Description: Concrete floor of former swimming pool. White-colored area is the painted surface of the pool.

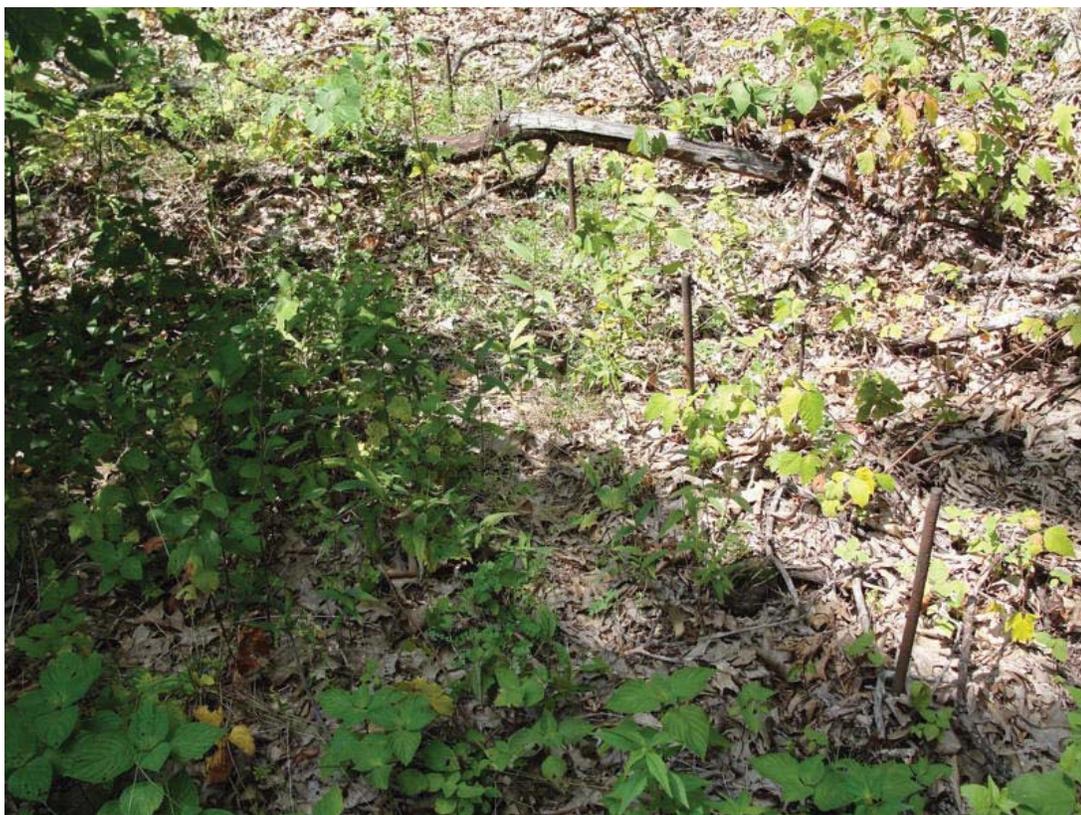
Photo 10

Location: Parcel 3, Enhanced Use Lease - 2010, Fort Leonard Wood, Missouri
