FINAL
SITE CLOSURE REPORT

FORMER CONSTRUCTION DEBRIS LANDFILL #1

CAMP NAVAJO
BELLEMONT, ARIZONA

October 1997

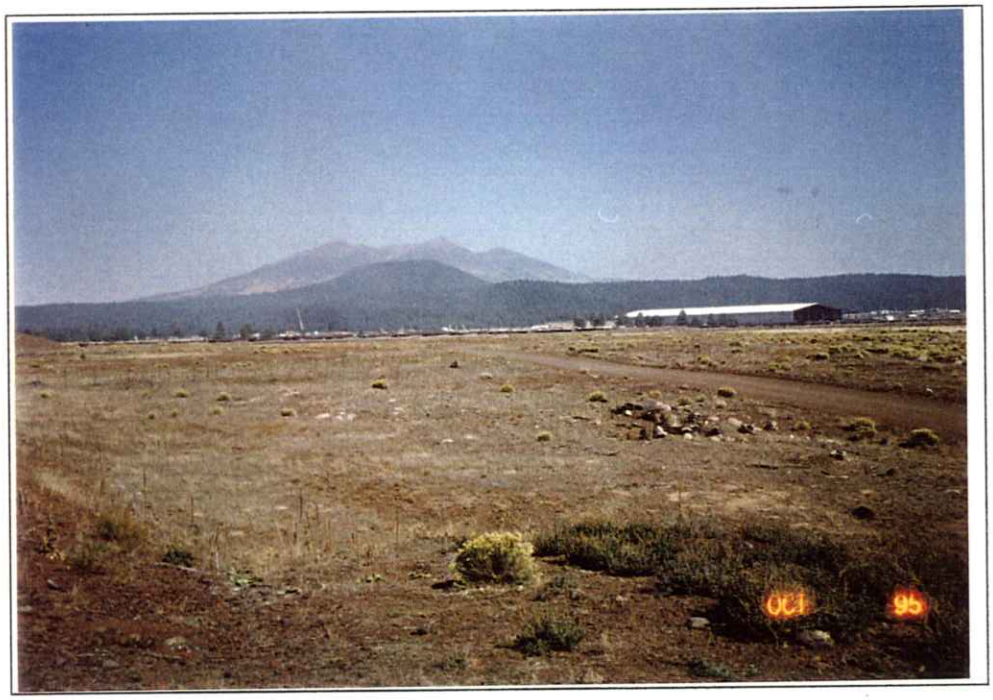
40-3 Same as 2, NE, 10/18/95, by Mike Guy

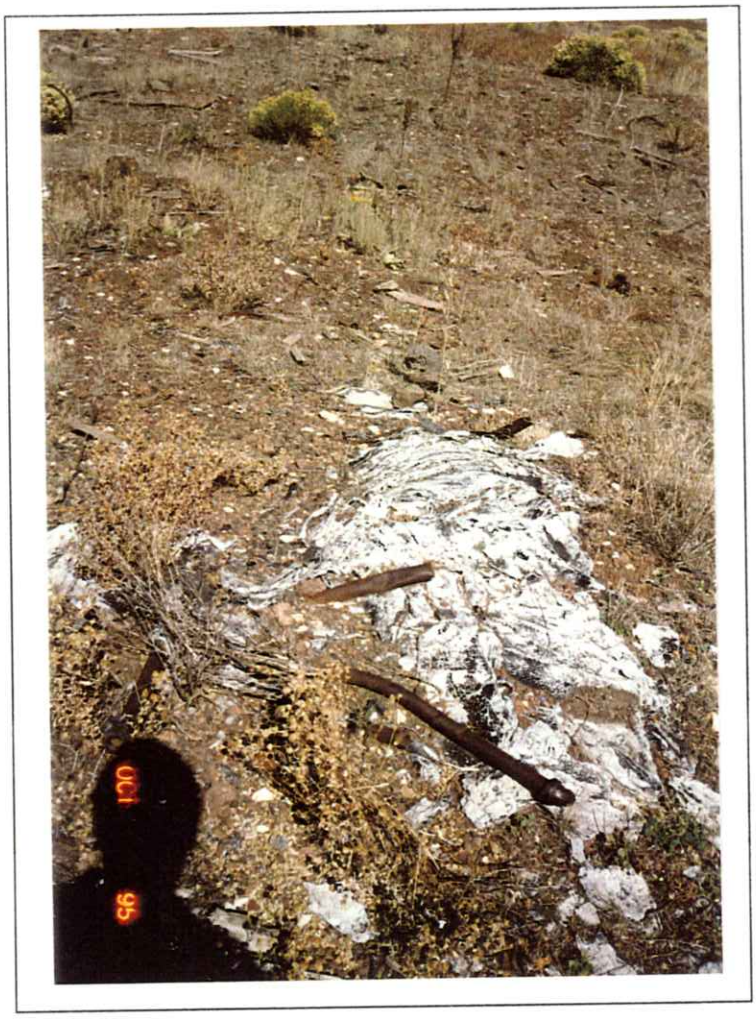
40-5 Standard debris pile, NE, 10/18/95, by Mike Guy
